# **Haworth Hall Deferred Maintenance – Replace Electrical Distribution System**

**KU Project No. 104-9568**

**Date: March, 2012**

**The University of Kansas, Lawrence Campus  
Office of Design & Construction Management**

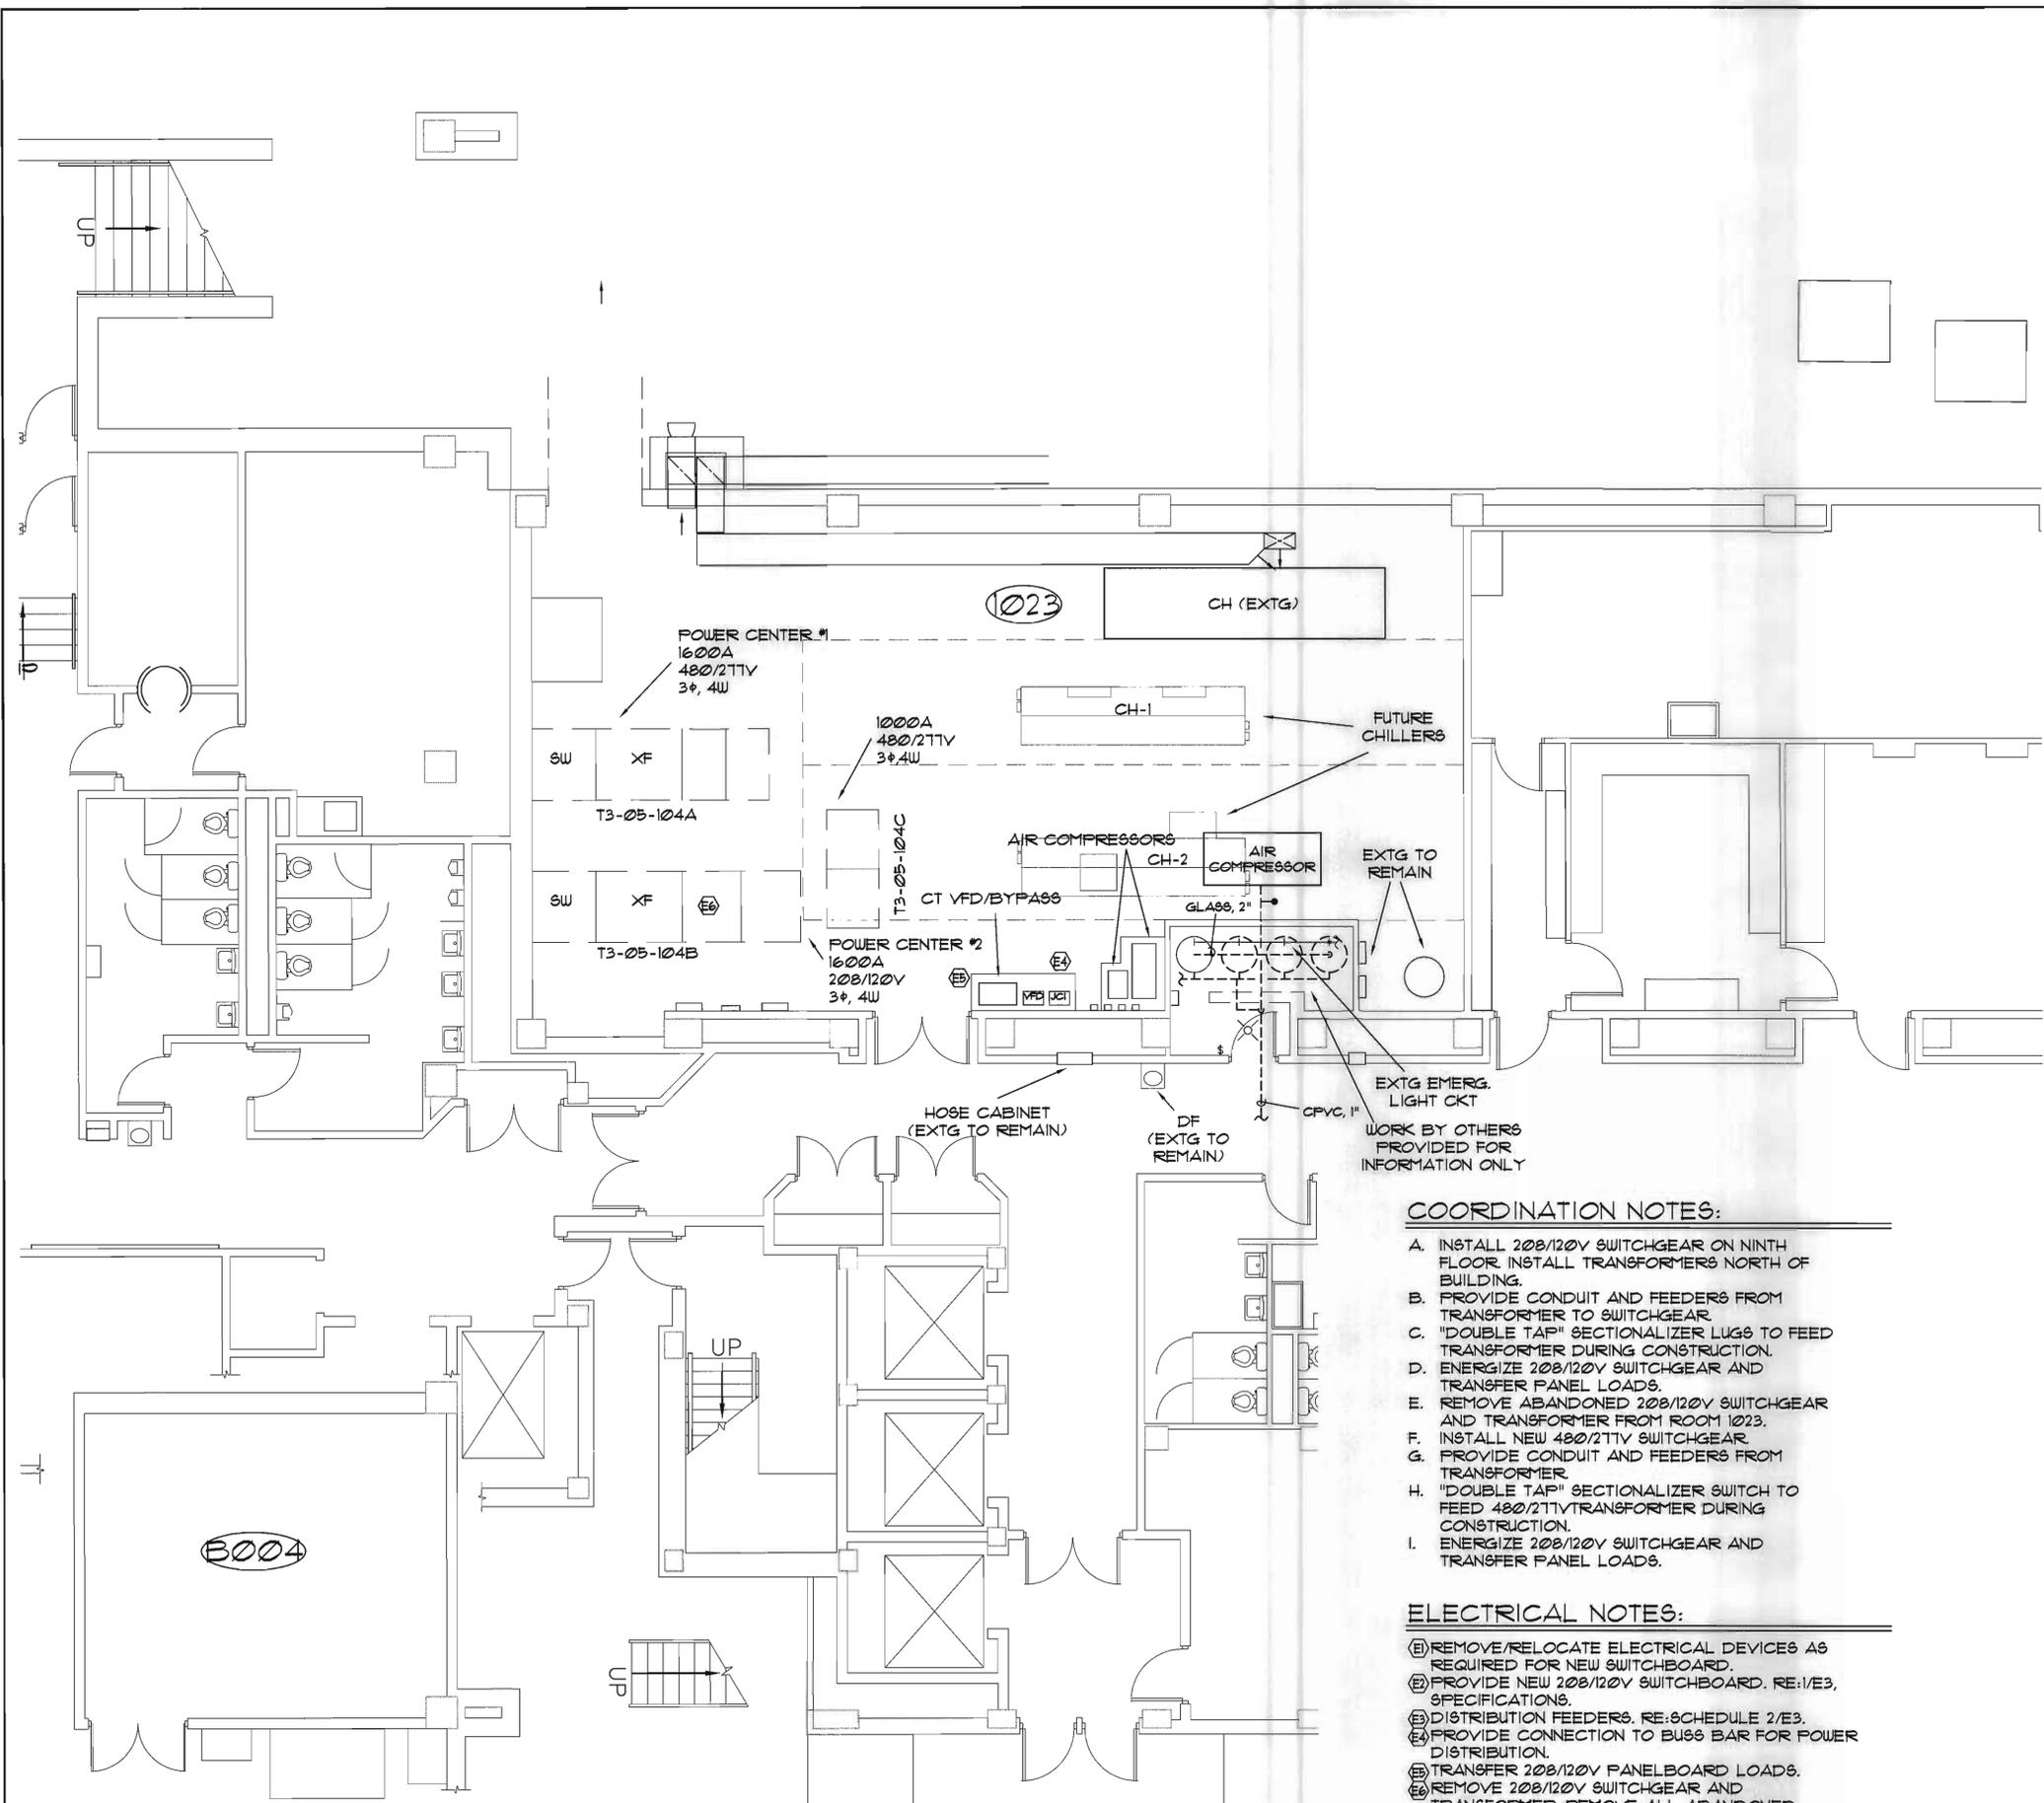
**DEMOLITION PLAN**

- (E) REMOVE/RELOCATE ELECTRICAL DEVICES AS REQUIRED FOR NEW SWITCHBOARD.
- (E) PROVIDE NEW 208/120V SWITCHBOARD. RE:1/E3, SPECIFICATIONS.
- (E) DISTRIBUTION FEEDERS. RE: SCHEDULE 2/E3.
- (E) PROVIDE CONNECTION TO BUSS BAR FOR POWER DISTRIBUTION.
- (E) TRANSFER 208/120V PANELBOARD LOADS.
- (E) REMOVE 208/120V SWITCHGEAR AND TRANSFORMER. REMOVE ALL ABANDONED CONDUITS AND CONDUCTORS.
- (E) PROVIDE NEW 480/21TV SWITCHBOARD. RE:2/E3.
- (E) USE EXISTING TEMPORARY FEEDERS TO ENERGIZE 480/21TV GEAR DURING REPLACEMENT.
- (E) NEW TRANSFORMER. RE: SCHEDULE

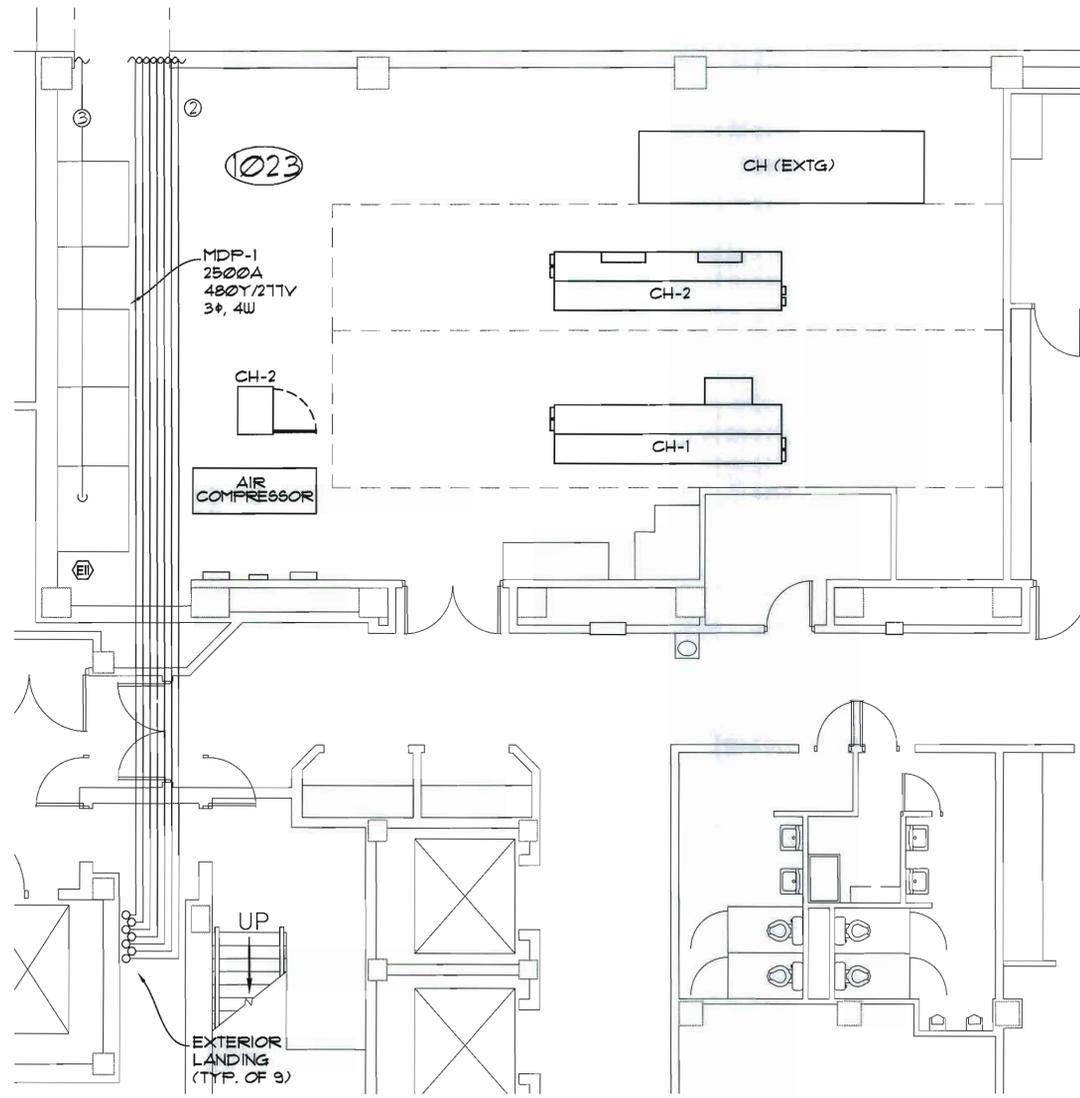
**ELECTRICAL PLAN (FIRST FLOOR)**

- (E) REMOVE/RELOCATE ELECTRICAL DEVICES AS REQUIRED FOR NEW SWITCHBOARD.
- (E) PROVIDE NEW 208/120V SWITCHBOARD. RE: 1/E3, SPECIFICATIONS.
- (E) DISTRIBUTION FEEDERS. RE: SCHEDULE 2/E3.
- (E) PROVIDE CONNECTION TO BUSS BAR FOR POWER DISTRIBUTION.
- (E) TRANSFER 208/120V PANELBOARD LOADS.
- (E) REMOVE 208/120V SWITCHGEAR AND TRANSFORMER. REMOVE ALL ABANDONED CONDUITS AND CONDUCTORS.
- (E) PROVIDE NEW 480/277V SWITCHBOARD. RE: 2/E3.
- (E) USE EXISTING TEMPORARY FEEDERS TO ENERGIZE 480/277V GEAR DURING REPLACEMENT.
- (E) NEW TRANSFORMER. RE: SCHEDULE

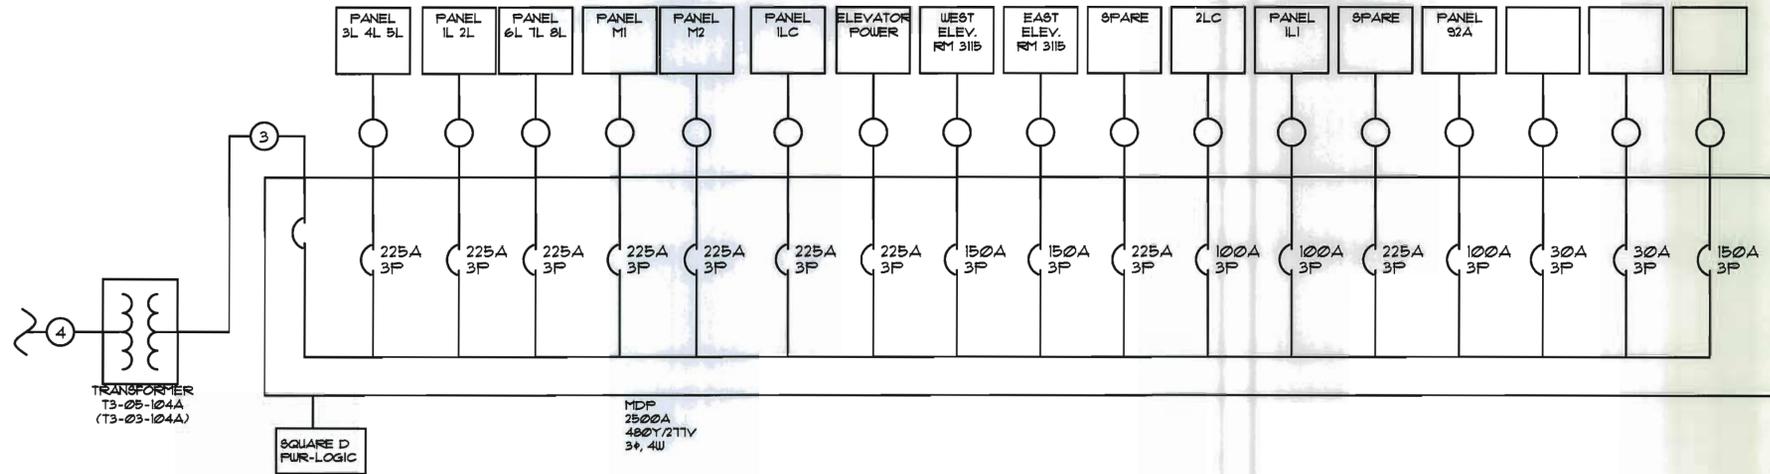
1  
 E300

ONE-LINE ELECTRICAL DIAGRAM  
 (480Y/277V)

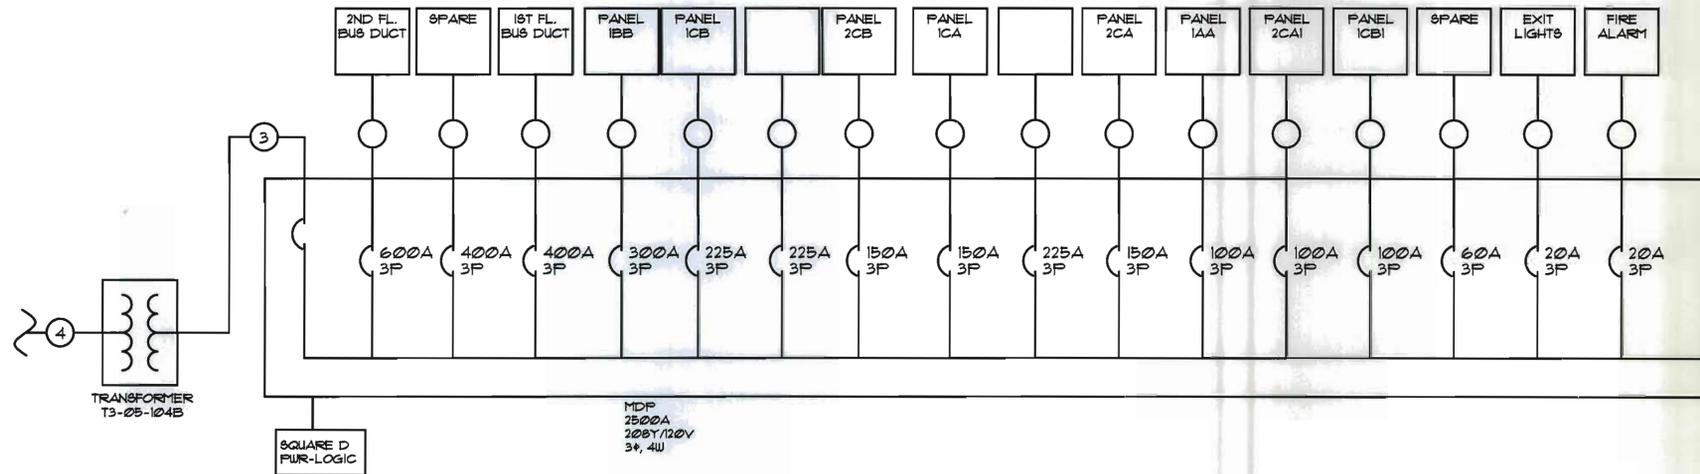
2  
 E300

ONE-LINE ELECTRICAL DIAGRAM  
 (208Y/120V)

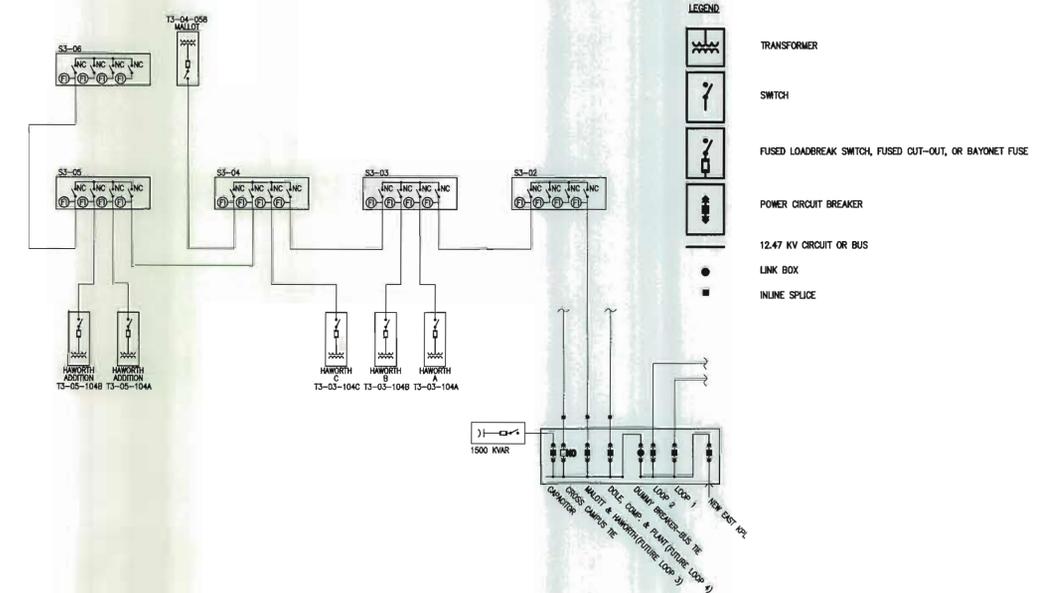
5  
 E300

ONE-LINE ELECTRICAL DIAGRAM

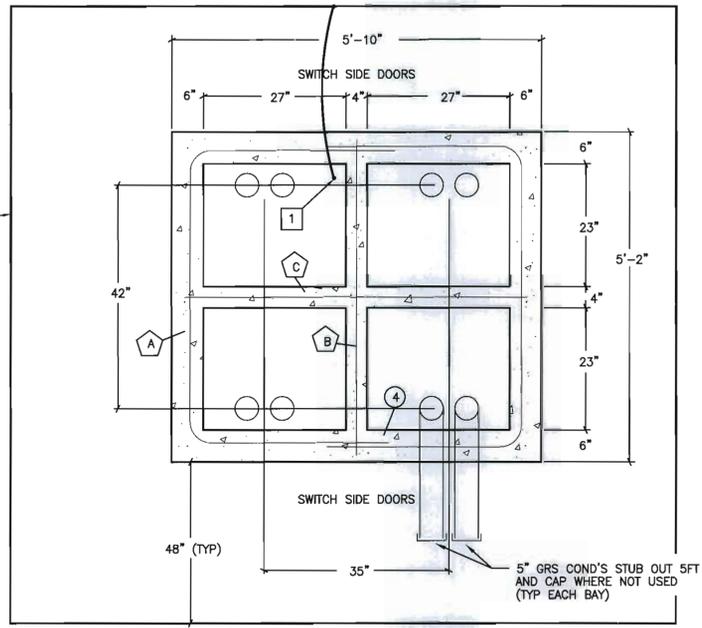
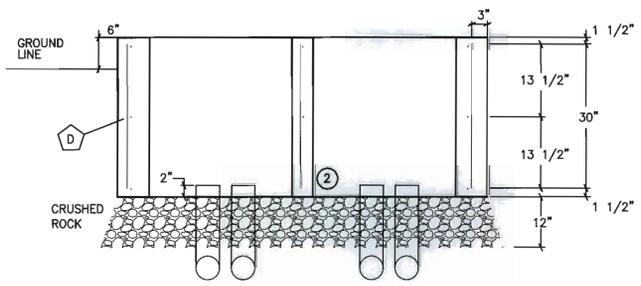
SWITCH PAD DETAIL 1  
NOT TO SCALE E301

MINIMUM REINFORCING		
BAR	QUAN.	SIZE
A	6	4
B	2	4
C	2	4
D	9	4

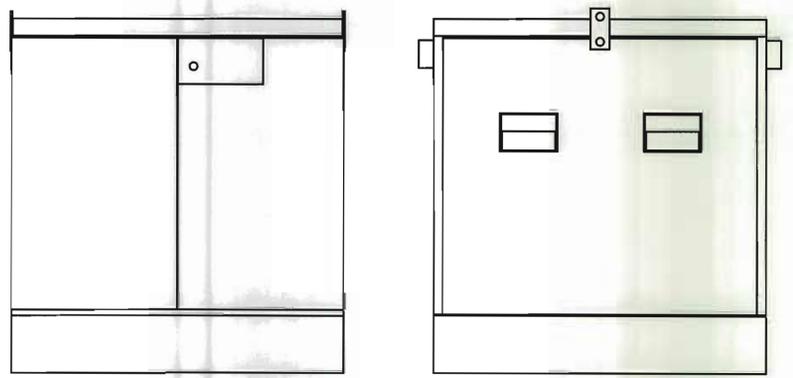
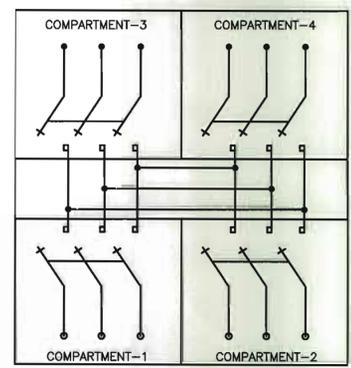
- NOTES:**
- COORDINATE EXACT DIMENSIONS WITH SWITCHGEAR SUPPLIER.
  - BASE SHALL BE PRE-CAST CONCRETE, 5000PSI AT 28 DAYS. BARBOUR CONCRETE 6219C OR APPROVED EQUAL.

- CONSTRUCTION NOTES:**
- GROUND ROD. BOND SWITCH ENCL. AND ALL CONDUITS.
  - #4/0 AWG BARE COPPER GROUND RING (24" MIN BLW GRADE). CONNECT TO GROUND ROD.

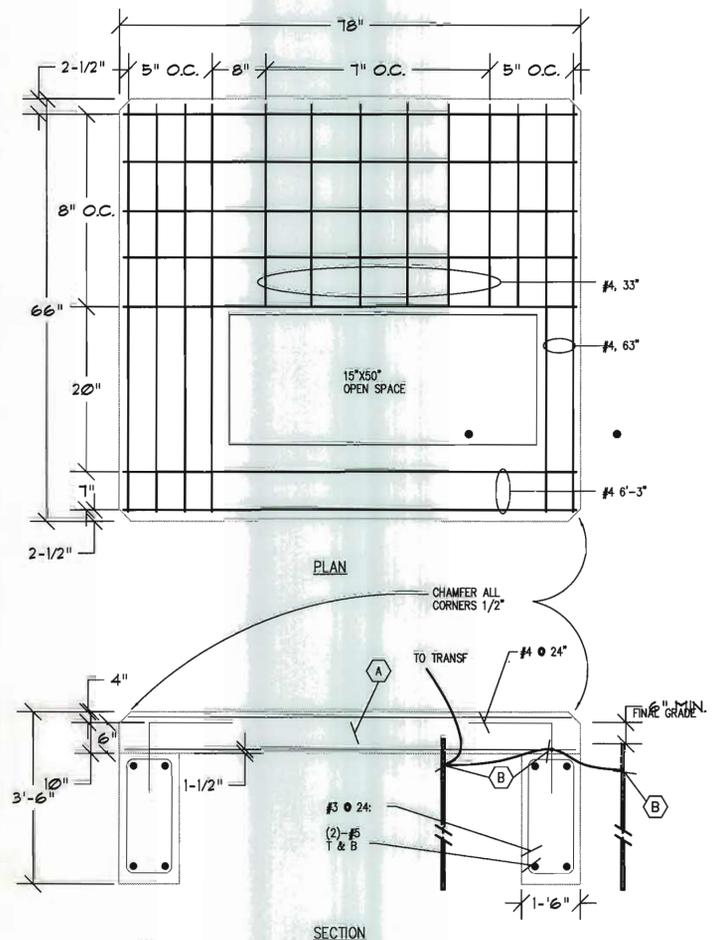
TRANSFORMER PAD DETAIL 3  
NOT TO SCALE E301

- NOTE:**
- ALL CONCRETE SHALL BE AIR ENTRAINED AND TEST 3000 PS(MIN.) IN 28 DAYS.
  - EXOTHERMIC WELD GROUND CONDUCTORS TO GROUND ROD AND REINFORCING STEEL (TYP). INSTALL GROUND RODS AND CONDUCTORS AS SHOWN ON THE PLANS.

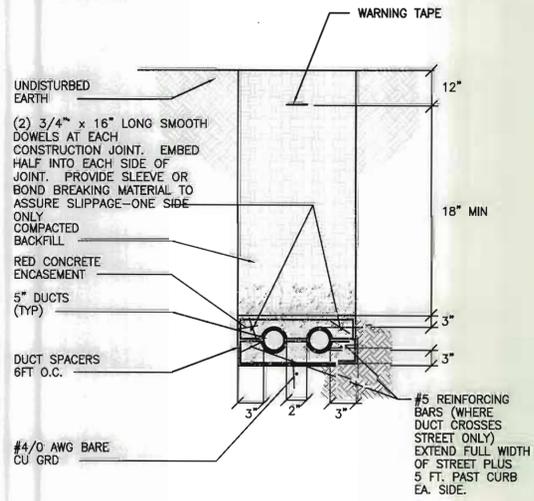
2x1 DUCT BANK 5  
NOT TO SCALE E301

CONTRACTOR NOTE: WHERE ANY DUCT BANK DIES INTO A MANHOLE, (2) # 5 X 3'-0" LONG REBAR DOWELS SHALL BE DRILL AND EPOXY ANCHORED INTO THE CONCRETE MANHOLE WITH 4" MINIMUM CONCRETE EMBEDMENT AND CAST INTO THE DUCT BANK CONCRETE TO PREVENT DIFFERENTIAL SETTLEMENT BETWEEN THE MANHOLE AND THE DUCT BANK. THE LOCATIONS SHALL BE AT THE SAME LOCATIONS SHOWN BELOW FOR CONSTRUCTION JOINTS.

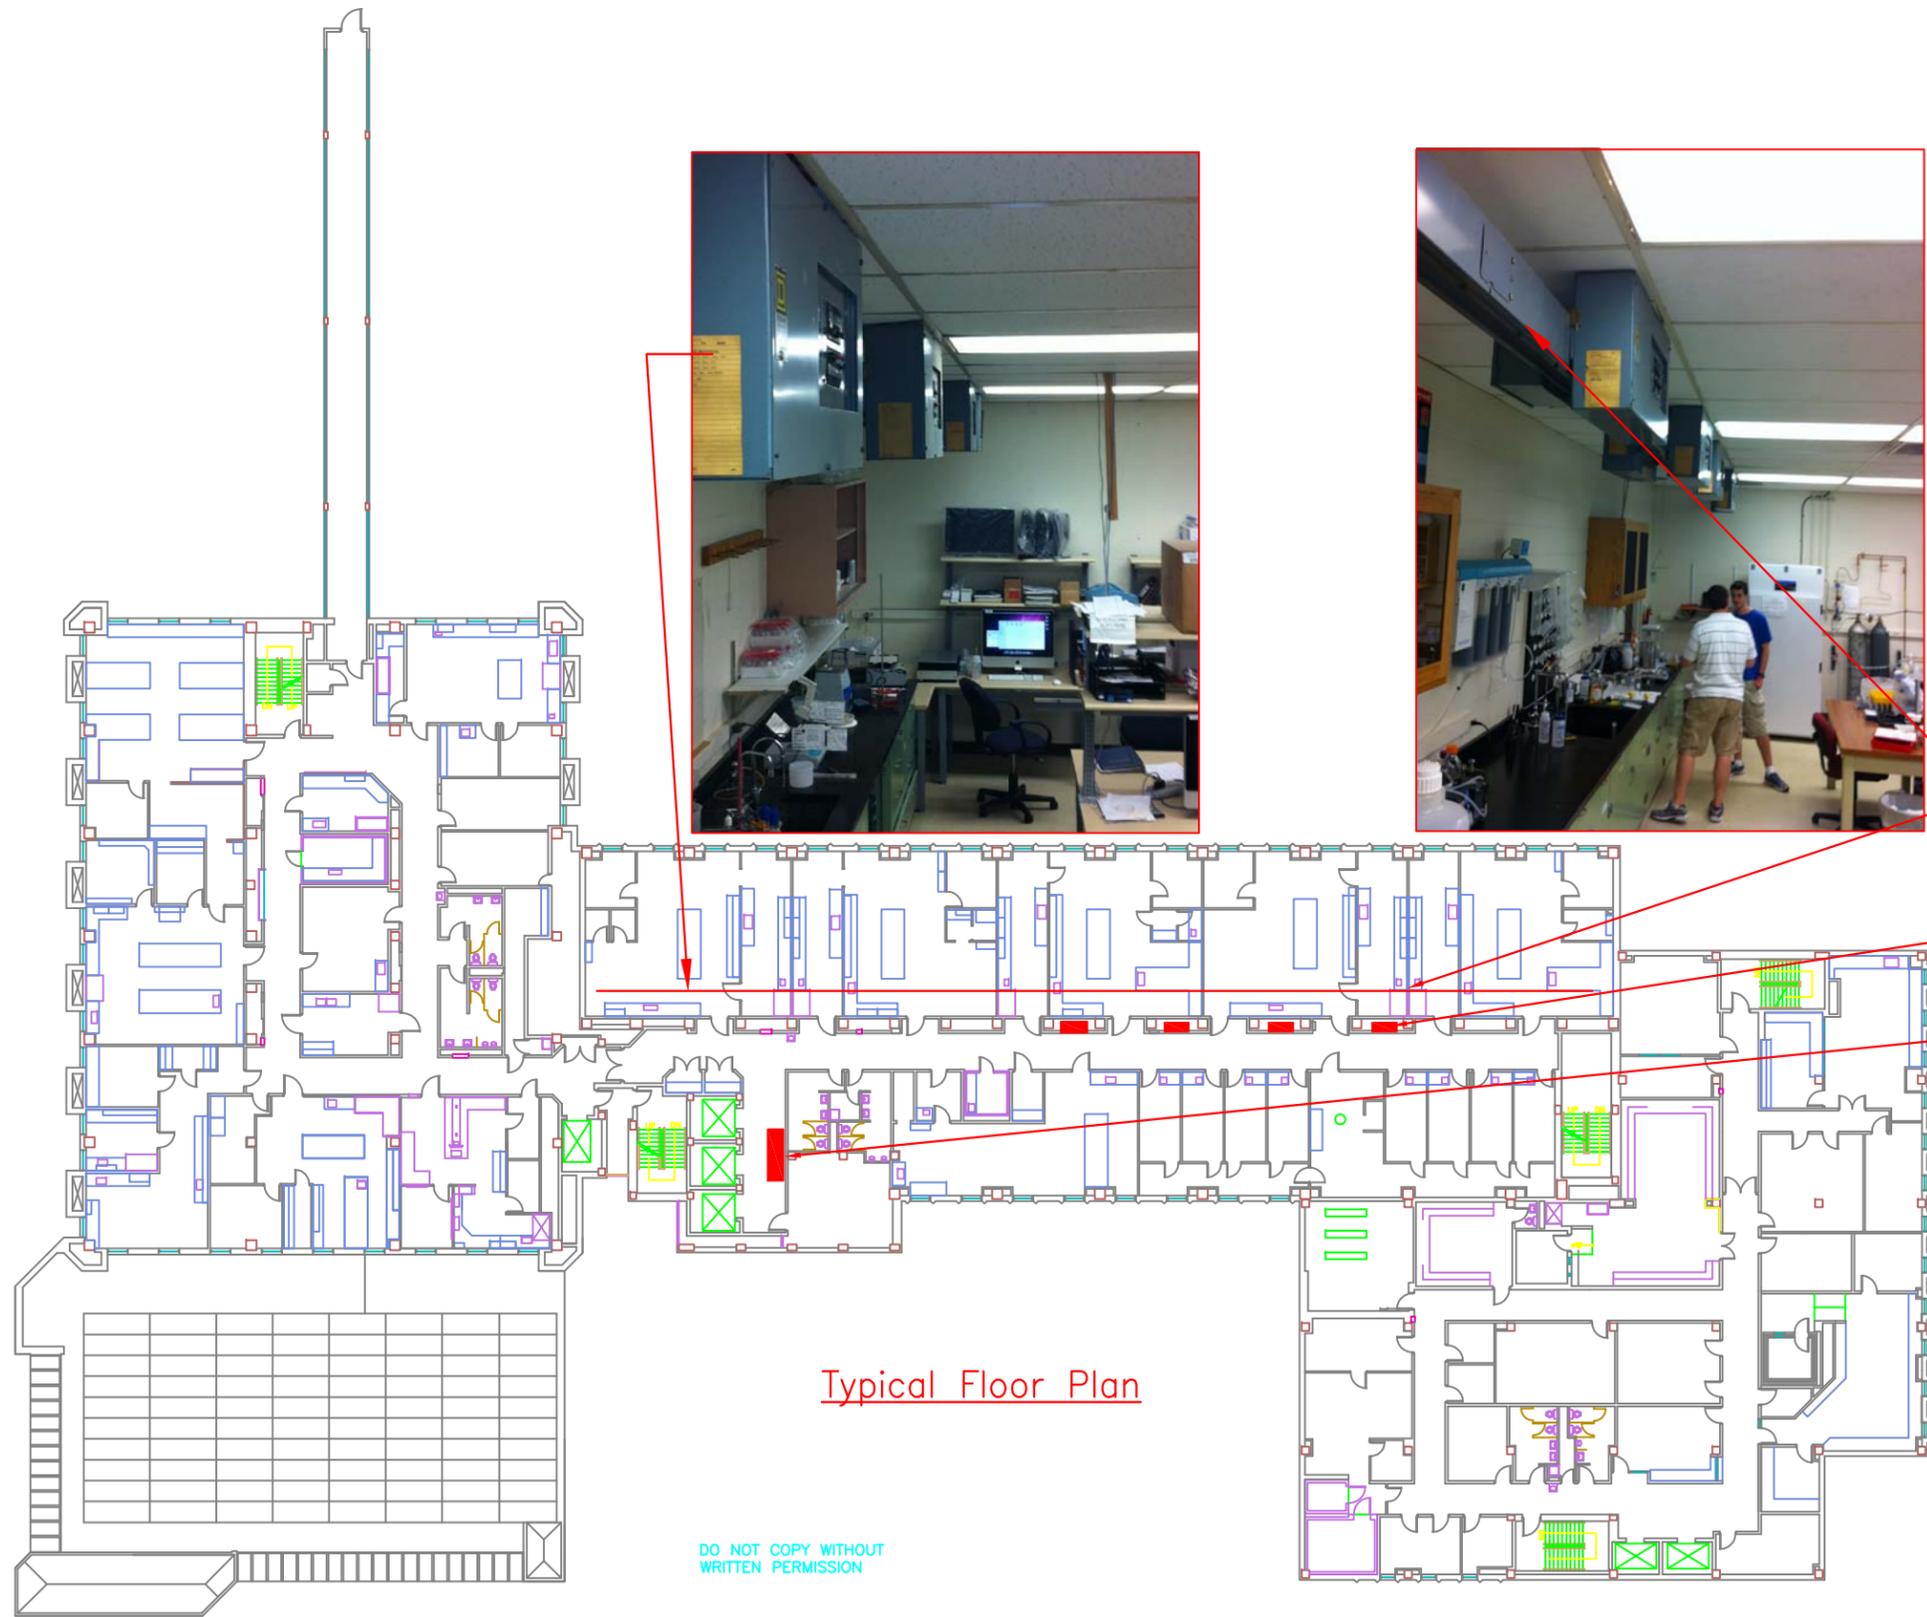
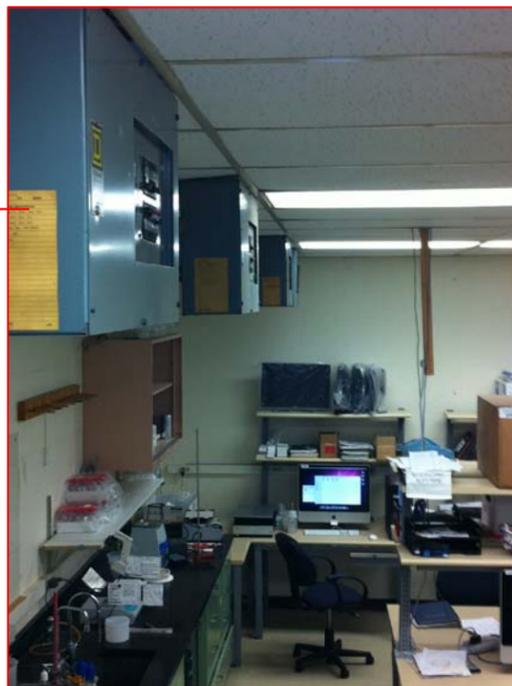
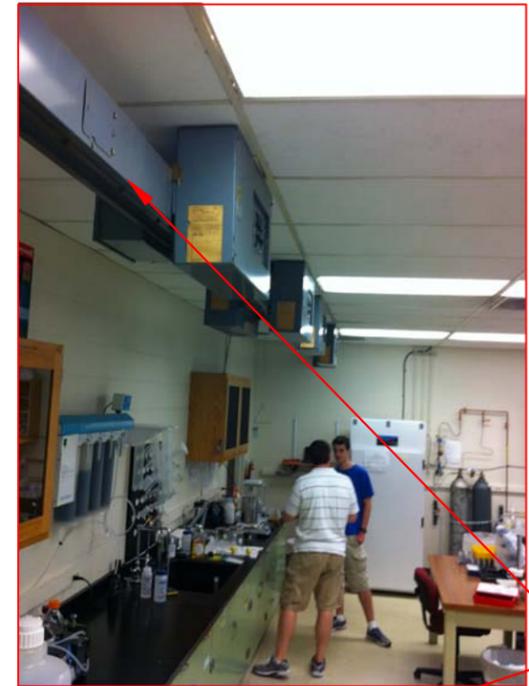
Reference Floor Plan  
 KU Project #104/9568  
 Haworth Hall Deferred  
 Maintenance  
 Replace Electrical Distribution  
 System  
 March 2012

Typical Overhead Electrical Bus

Feasible Location for Branch Circuit Panelboards

- Review the sketch included as Appendix B of this program for reference. The intent of the sketch is to inform consultants who are reviewing this program as to the configuration of the existing bus plug distribution system,

and to illustrate feasible locations for the anticipated replacement distribution panelboards.
